Tosoh Accident in Japan

By: Christina Meyer

Activity

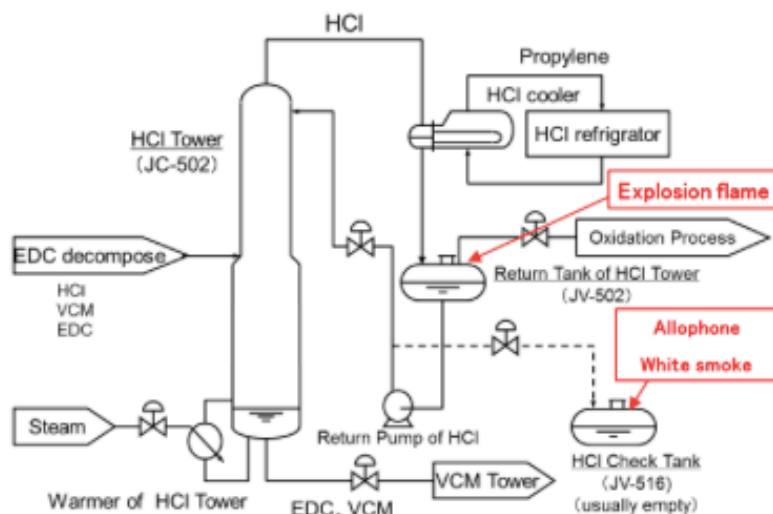
was partial, the temperature balance of the HCl tower altered and the middle tier temperature fell from 80°C to 57°C. To regain the temperature lost, steam was increased and reflux volume was decreased. The operator did not understand that they should control the top and bottom temperatures of the HCl tower. The temperature at the top of the tower typically is -24°C, but it increased to 38°C. The VCM was mixed in the upper part of the tower and the back-flow tank also. The operators believed the HCl tower condition was stable because the middle stage was restored to its normal temperature. After the VCM mixed in the back-flow tank, it then mixed with the oxidation line B causing the entire production facility to halt. The managers recognized the temperature at the top of the tower was not normal and assumed the VCM mixed into the back-flow tank, but were unaware of the 1,1-EDC that was produced. They stopped the back-flow pump, which brought the level of HCl in this tank back to 100% and then sealed it. The HCl tower refrigerator was stopped and the back flow tank of the HCl tower was detached from the main tower, so the backflow tank of the HCl tower was closed. The transfer of liquid from the back-flow tank of the HCl tower to the liquid HCl temporary receiving tank started and the pressure of the liquid HCl in the temporary tank began to increase, something the operators were unaware of. They soon realized the pressure increase in the temporary tank and they began pressure relief action. The alarm sounded and white smoke discharged from the top of the liquid HCl temporary tank during the relief. The pressure of the back-flow tank of the HCl tower rose to 2.0 MPa and it can hold only a pressure of 1.9 MPa. This pressure caused the tank to rupture, explode and burst into flames.
