Details Matter in Process Safety!

March 2015

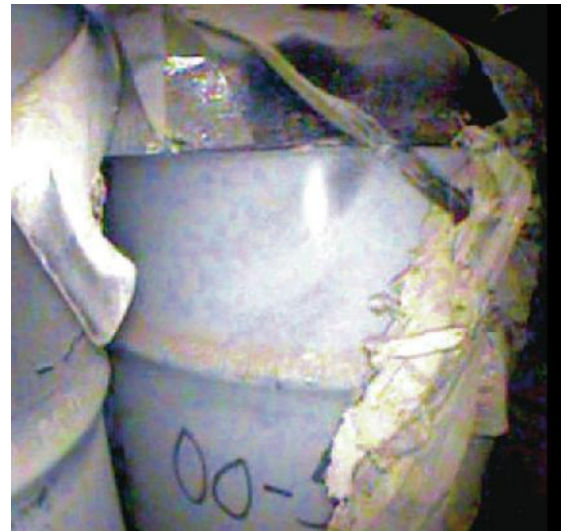
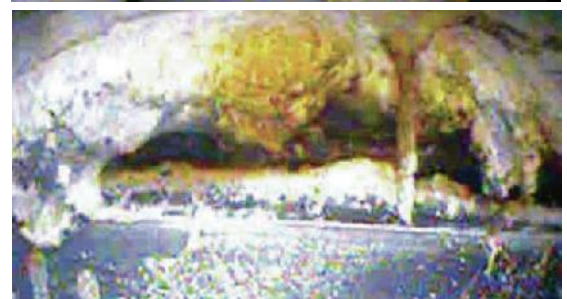
There was an exothermic reaction in a drum of radioactive waste material in a nuclear waste repository. The drum ruptured, releasing small amounts of radiation, exposing other waste drums to elevated temperature, and contaminating 20 workers with low levels of radiation. Other drums containing similar waste material may also be in danger of rupture. The facility had to be shut down and the recovery cost is expected to be several hundred million dollars.

A chemical reaction occurred in the drum, which contained acidic waste material and oxidizing chemicals including nitrate salts, as well as an organic absorbent. This mixture can react to generate heat and pressure.

While a final determination of causes has not been made, newspaper reports indicate that a typographical error in a revision to a facility policy may have resulted in the use of the wrong absorbent! The revised policy specifically stated that an organic absorbent should be used, when it should have specified the use of an inorganic absorbent (a clay based absorbent). The error was not recognized and the absorbent was changed, resulting in the incident. Details matter! Those two letters, “i” and “n,” make a huge difference in the characteristics of the absorbent!
